Subject: silt fence @ Pandora and Snowball

Erosion Control at base of waste rock for Pandora and Snowball Mines.

Project completed on 04-17-2009

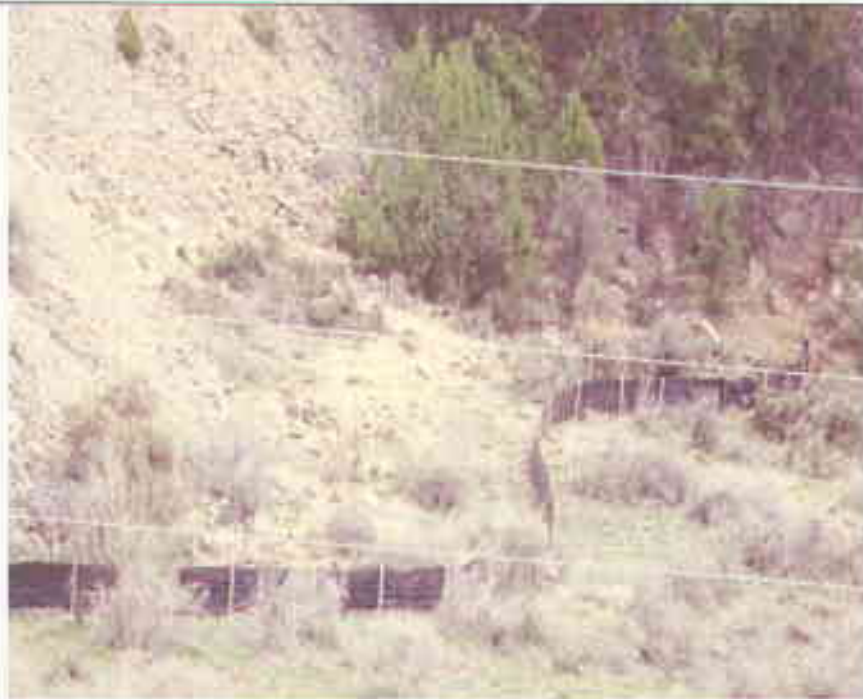
These pictures show the silt fence which has been installed at the base of the Pandora waste rock pile. The straw berm installed last summer was destroyed by cattle during the winter.

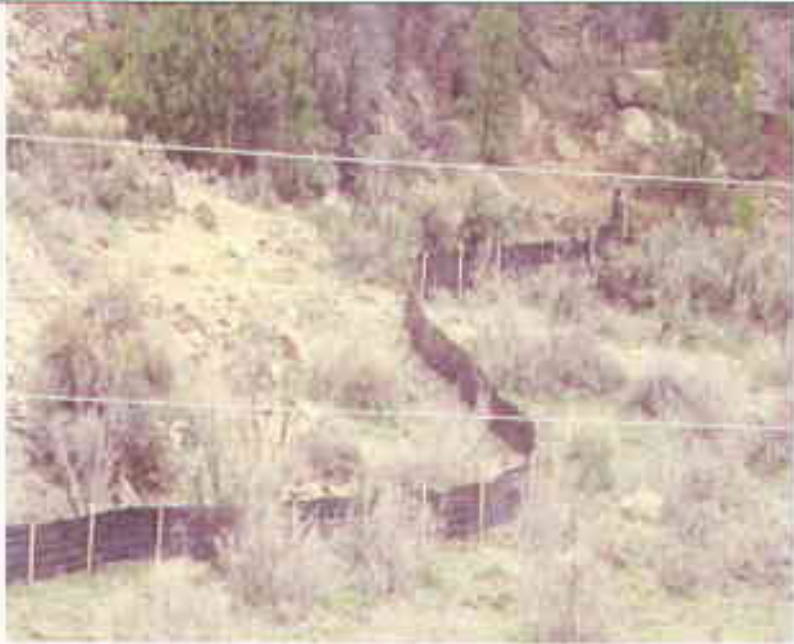
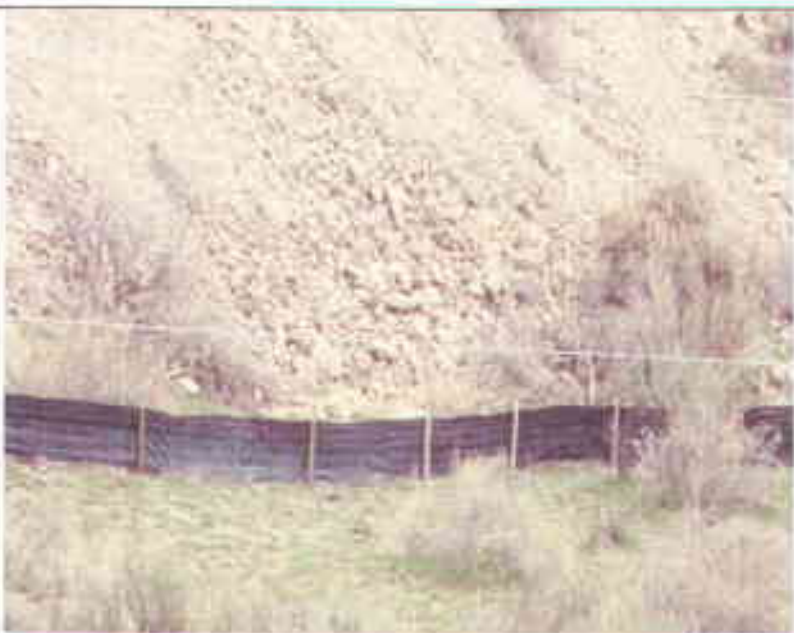
The fence is wire backed and buried into the ground.

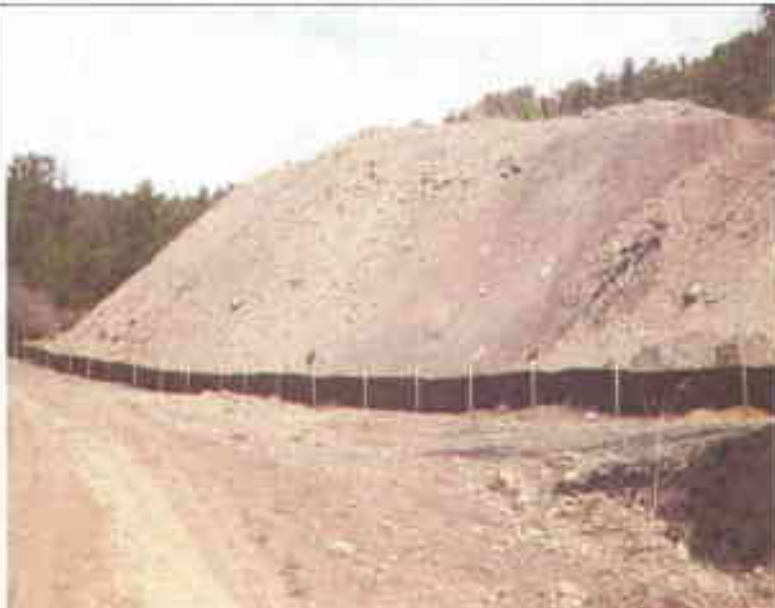
These next photos are of the silt fence which was installed at the Snowball Mine.

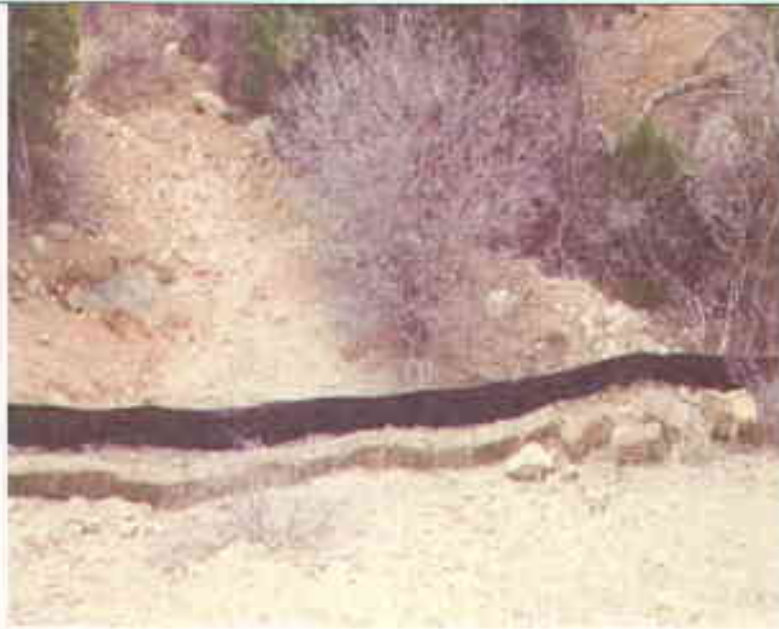
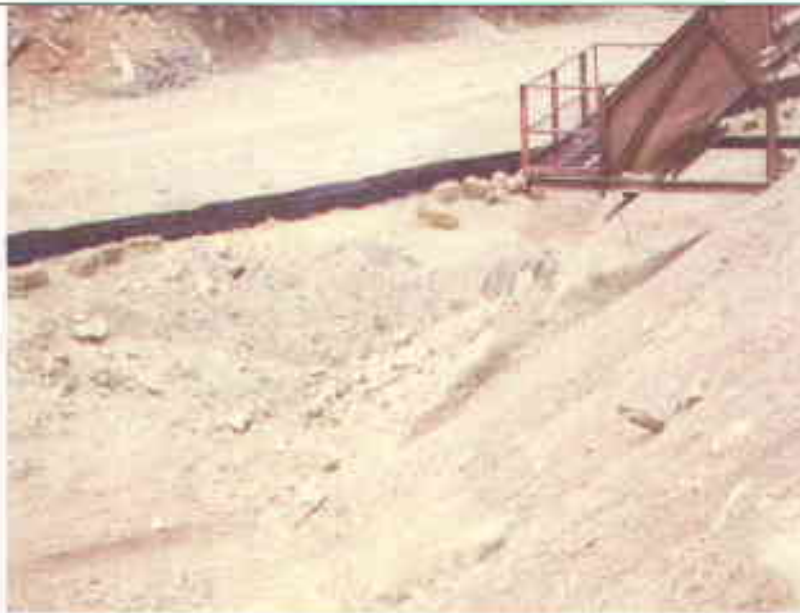
Taken from
the top of
the waste
rock pile.
Some of the
straw berm
remained
undisturbed
but most was
destroyed.
